Post-Tensioned Retrofitting Maintains Landmark's Aesthetics

Team effort, sophisticated technology solve problems at famed architect Frank Lloyd Wright's *Fallingwater* creation

BY JAMES LOPER AND JASON HUGHES

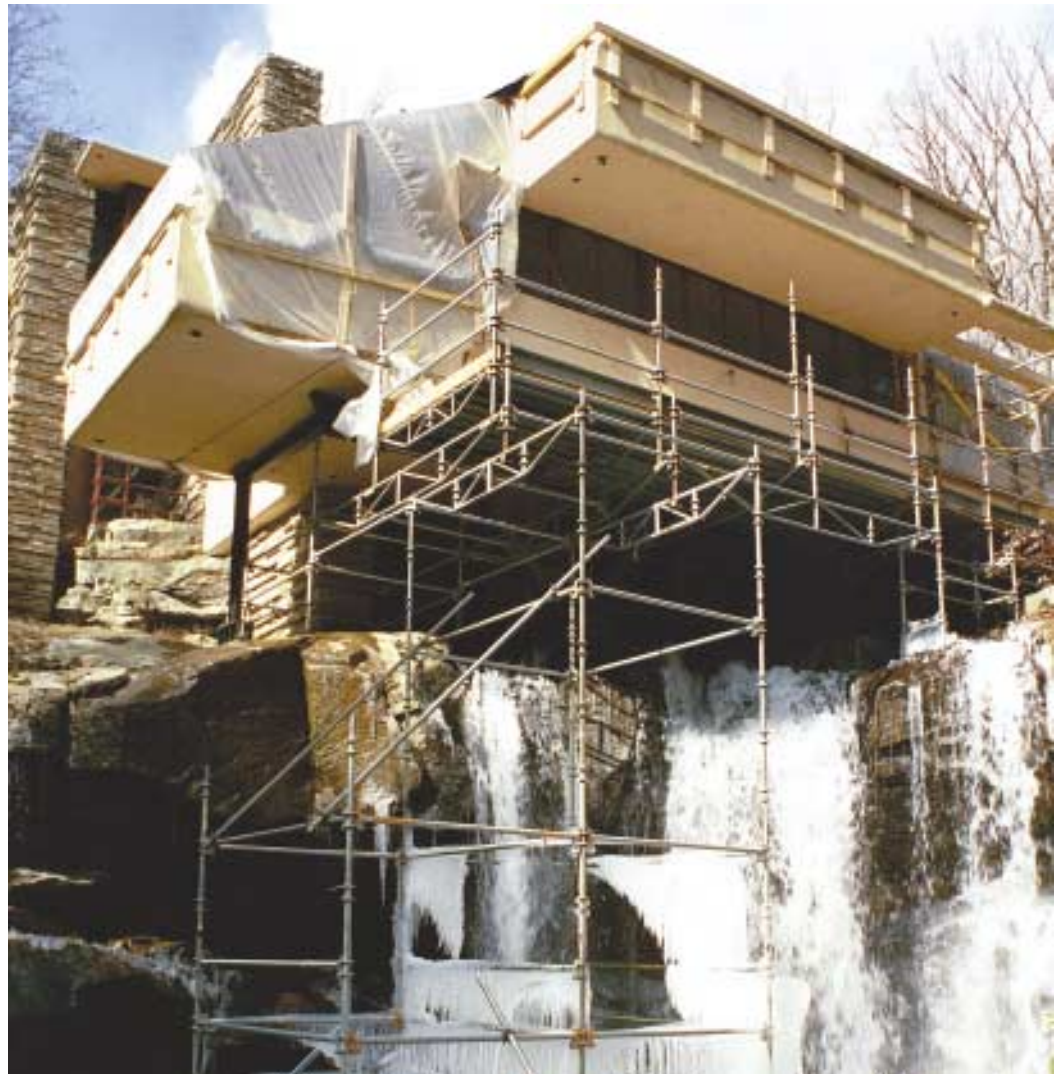
Fig. 1: View looking up at *Fallingwater* from stream below. The home is comprised of a series of concrete cantilevered trays. From downstream, water appears to pour out of the structure

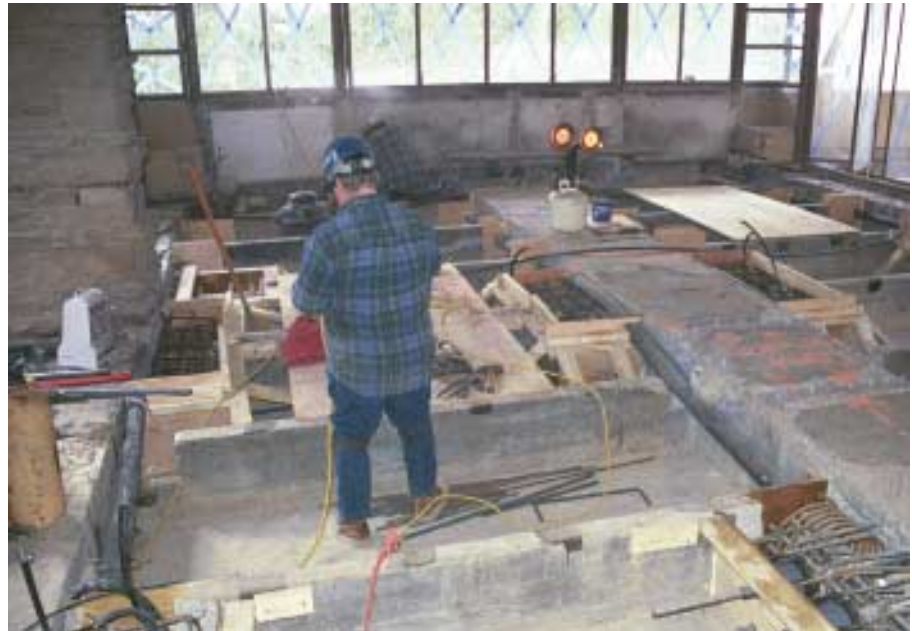
Fig. 2: One of the primary girders at the main level that cantilevers over the stream and supports the south parapet wall (background). Note the four structural window mullions at the parapet and the dead-end anchorages with spiral reinforcement and grout vents (foreground)

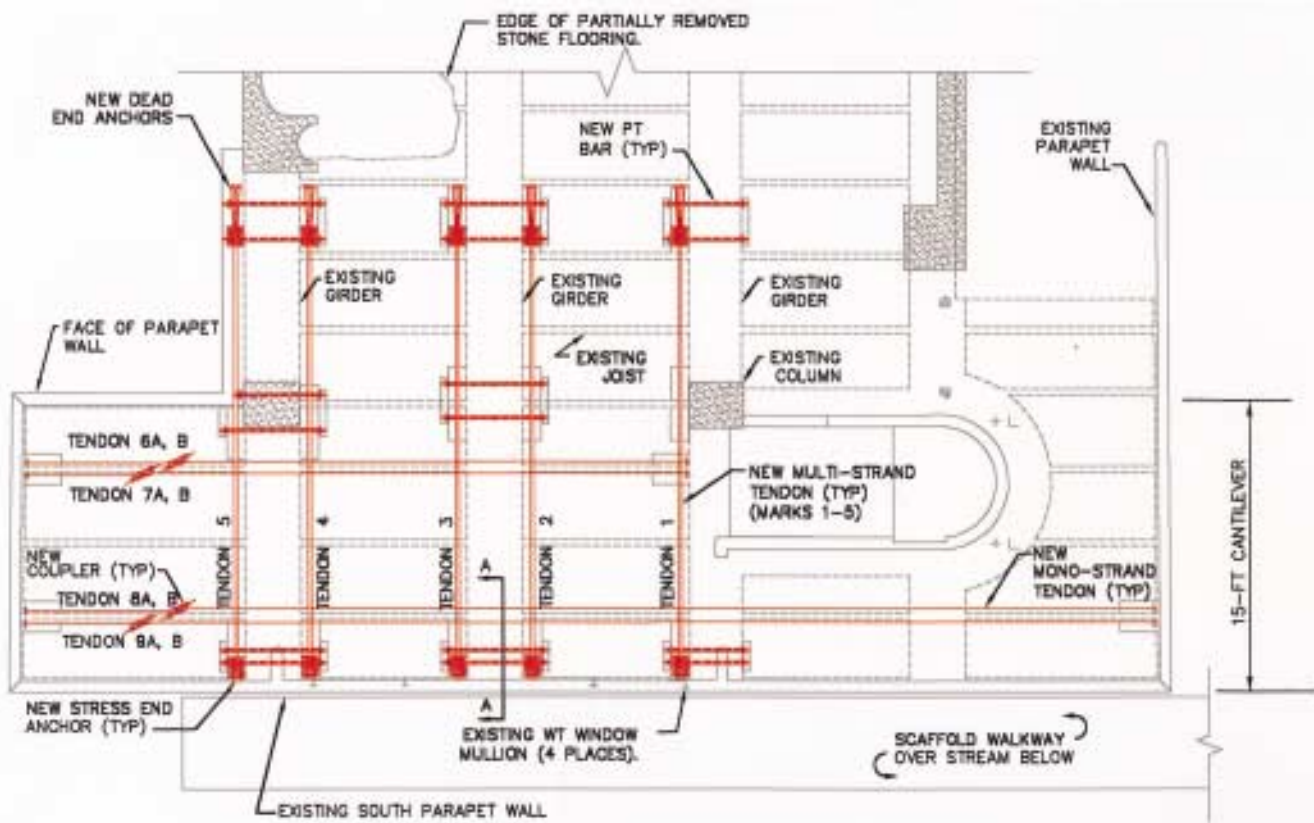
FIGURE 3 - FIRST FLOOR TENDON LAYOUT

Fig. 3: Plan view of the first floor showing the tendon layout. The 3-ft-wide (1 m) girders cantilever from the bolsters about 15 ft (4.6 m) over the stream. The monostrand tendons were stressed from within the structure using special splice couplers

Similar anchor blocks were positioned for the monostrand tendons that spanned in the east-west direction. The post-tensioning contractor stressed the monostrand tendons from within the structure using special splice couplers (Fig. 3). This was done to avoid the need for cutting additional access openings in the parapet walls.

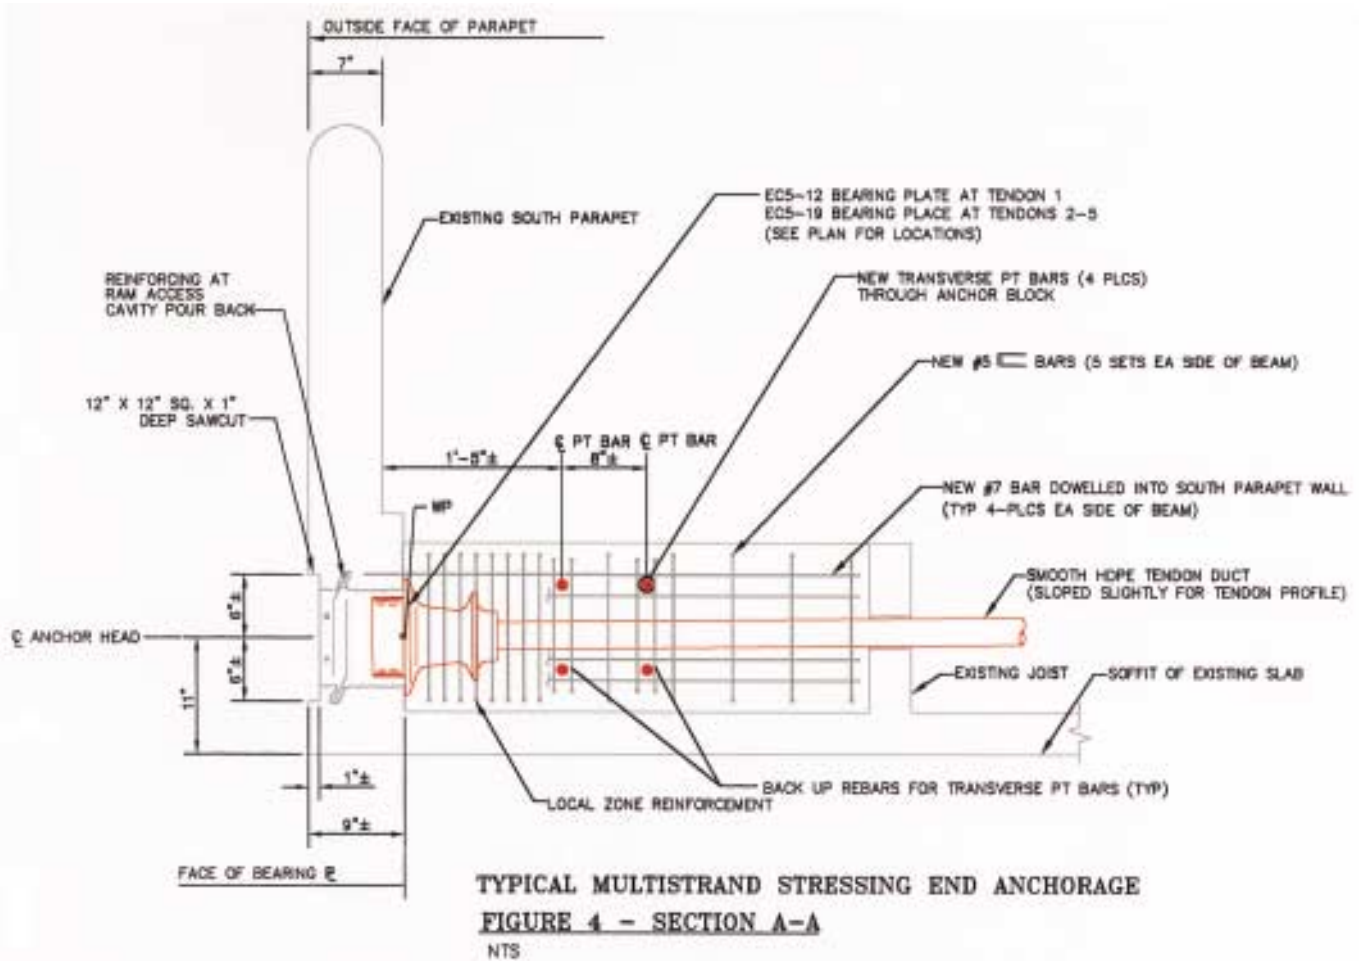
Fig. 4: Typical reinforcement detail for a multistrand stressing end anchorage. Small openings were sawcut into the existing south parapet wall to gain access for stressing

The first step was layout and placement of the monostrand and multistrand tendons and their anchorage blocks. The team paid special attention to the amount and location of dowels, spirals, and transverse post-tension bar reinforcement at the anchorage blocks (Fig. 4 and 5).

Craftsmen doveled new reinforced concrete blocks into the sides of the existing girders to anchor and profile the post-tensioning. Small openings were sawcut into the existing south parapet wall to gain access for multistrand tendon stressing (Fig. 4). Dead-end anchors were placed at the north end of the girders.

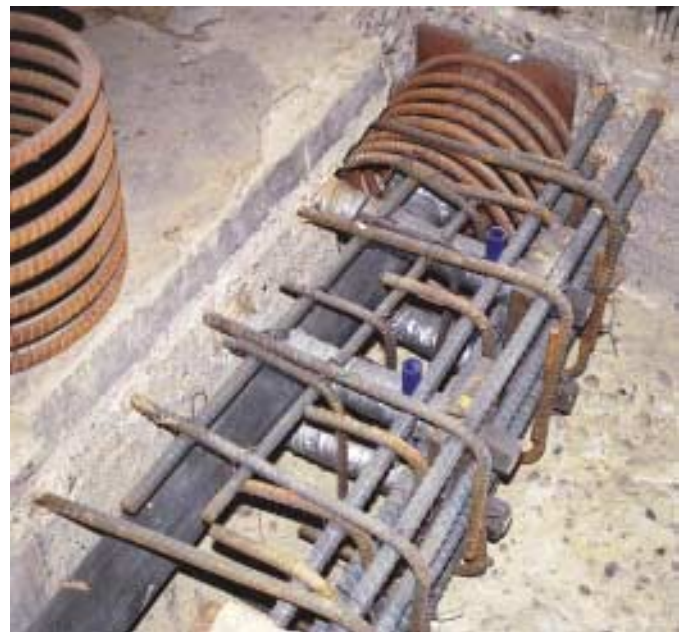
Fig. 5: View of a typical multistrand stressing end anchorage for one of the three primary cantilever girders spanning in the north-south direction

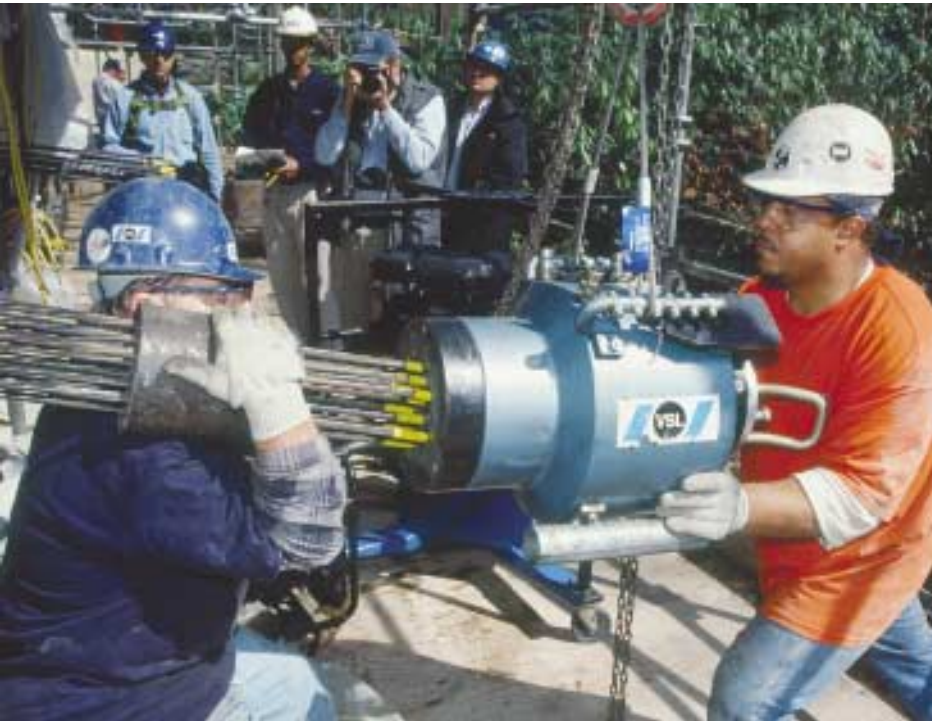
Fig. 6: Multi-strand tendons were carefully stressed in stages using a hydraulic ram. Here, technicians position extender nosing (left) and ram over the strand tails in preparation for stressing

The next step was to stress the tendons. Stressing operations were carefully staged and sequenced. The post-tensioning contractor stressed the four monostrand tendons in the east-west direction and then the five multistrand tendons in the north-south

direction (Fig. 6). Stage loading was beneficial because it allowed engineers to visually inspect the structure and monitor strains and deflections periodically.

The monostrand tendons were tensioned to jacking forces of approximately 43 kips (191 kN) each. Technicians post-tensioned the 10-strand and 13-strand tendons to jacking forces of 300 and 390 kips (1335 and 1735 kN) each, respectively. They then grouted the multistrand tendons with a high-quality, low-bleed cementitious grout mixture. VSL Project Manager Dennis Sanschagrín noted, “The knowledge and procedures we developed during several recent major bridge projects—especially regarding materials, installation techniques, and quality control—benefited us during the tendon grouting phase of this project.”
